**A/E Services for Structural Repairs at
Various State Parks**

AEOI 0310 DNR1800000009

WDP & Associates Consulting Engineers, Inc.

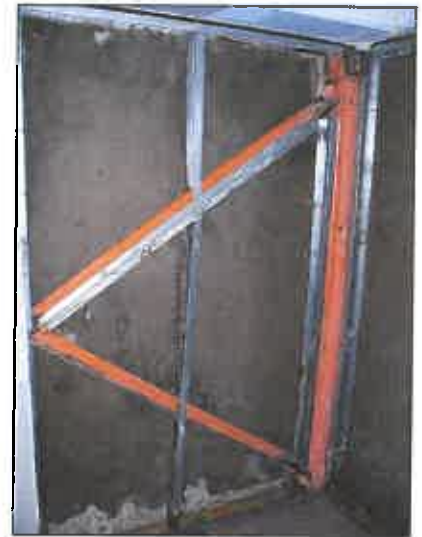
Structural section loss

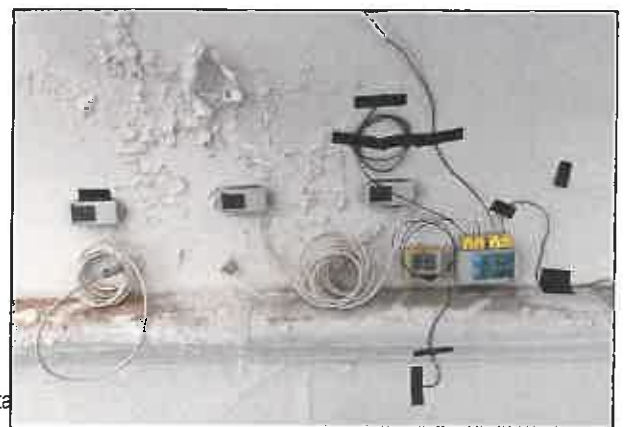
Field instrumentation (above) collects the data used to conduct

spaces, basements, attics, and plenums. We also have temperature and relative humidity data logging probes that can be installed interstitially within building enclosure assemblies in order to determine the conditions within stud cavities, mass masonry walls, exterior cavities and other locations in an assembly where elevated moisture can lead to long term failures. Furthermore, we can assess the in-situ thermal performance of existing wall assemblies utilizing thermocouple and heat flux sensors to measure the actual behavior of a wall.

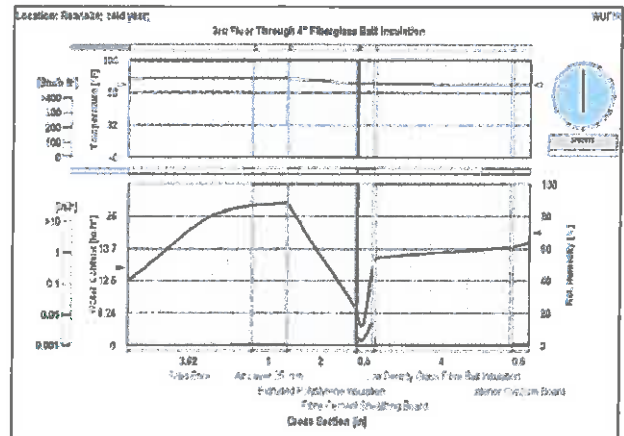
WUFI output of data gathered with field instrumentation.

Hygrothermal analysis is the study of the simultaneous heat and moisture transport within wall assemblies. WDP routinely performs both transient and steady-state hygrothermal analysis. We use WUFI Pro software developed by the Fraunhofer Institute to conduct the transient analysis and either hand calculations, internally developed spreadsheets, or the Heat, Air and Moisture (HAM) toolbox by Quirouette Building Science for steady-state analysis. Our analysis is generally conducted in accordance with ASHRAE 160 “Criteria for Moisture-Control Design and Analysis in Buildings” and ASHRAE Fundamentals. We routinely perform these analyses in conjunction with our data logging capabilities in order to calibrate our models and provide an accurate representation of the existing conditions. This is

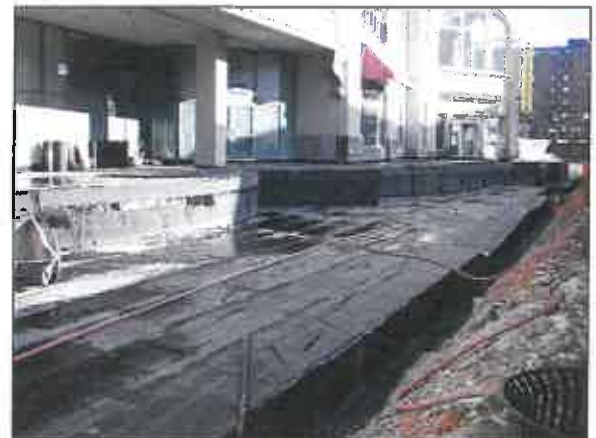
Plaza hardscape demolition and new continuous, fluid-applied waterproofing

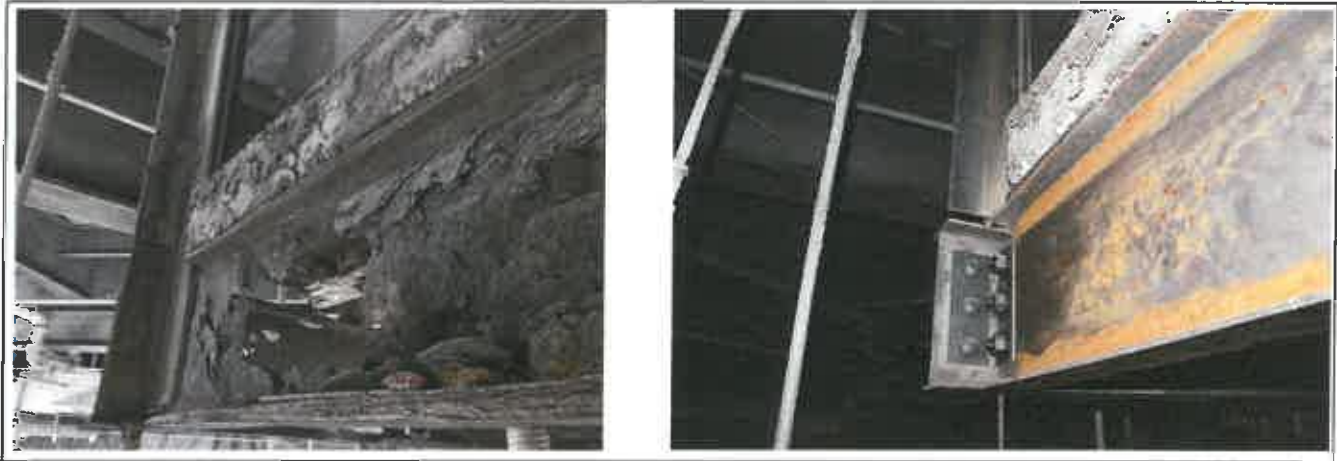
Plaza staircase structural supporting members with holes through the web before repair [left] and after repair [right]

compared against the service loads determined through use of a finite element model. Some girders and structural members experienced severe section loss and needed to be outright replaced in kind (Figure 2). WDP's analysis and strengthening design included both composite and non-composite beams, built-up sections, as well as bolted and welded connections (Figure 3). Many girders and areas of decking experienced section loss and needed to be strengthened to achieve adequate design capacity for anticipated service loads (Figure 4).

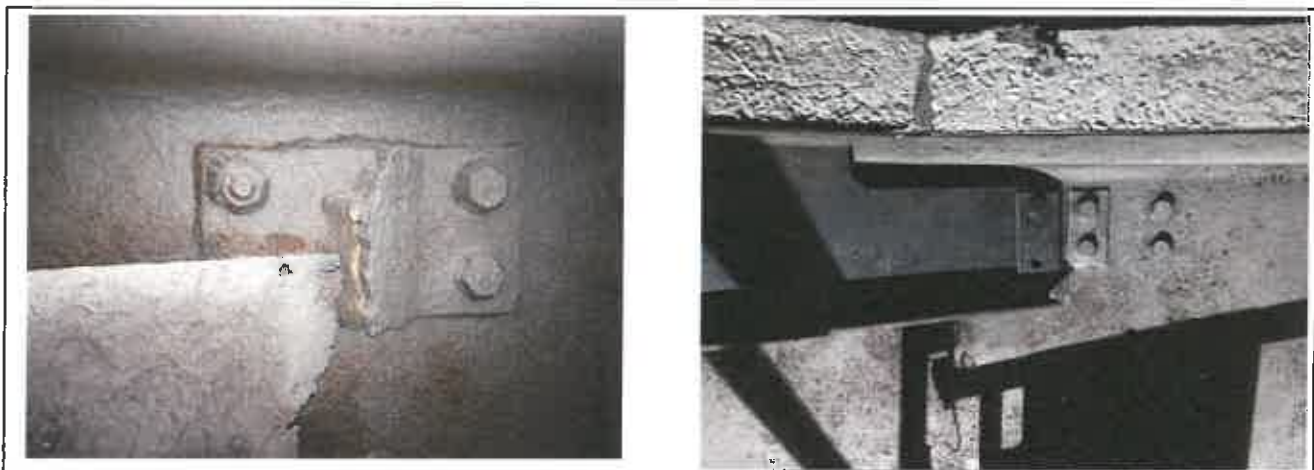
Figure 3 – Secondary framing connection with 100% section loss before repair [left] and replacement connection [right]

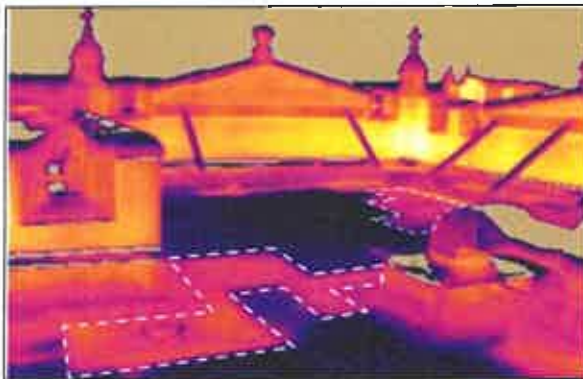
Infrared Thermography Used to Identify Water Leakage

We also routinely deploy non-destructive testing (NDT) methods to evaluate and document existing conditions. WDP has the unique capabilities of performing highly specialized field sampling, testing, and structural analysis, should the need arise. WDP's team is well experienced in performing nondestructive testing of structures, including Infrared Thermography, Pachometer survey, Surface Penetrating Radar (SPR), Impact-Echo (IE), and Ultrasonic Pulse Velocity (UPV). These highly specialized test methods, all performed by WDP personnel, can be invaluable in identifying existing conditions, developing the proper diagnosis, and subsequently, the most effective repair methods for a given structure. Particularly, in the evaluation of damage due to masonry expansion, these tools are often used to identify wall conditions and locations of reinforcement or supports in brick masonry walls so that we can better understand the behavior of the condition.

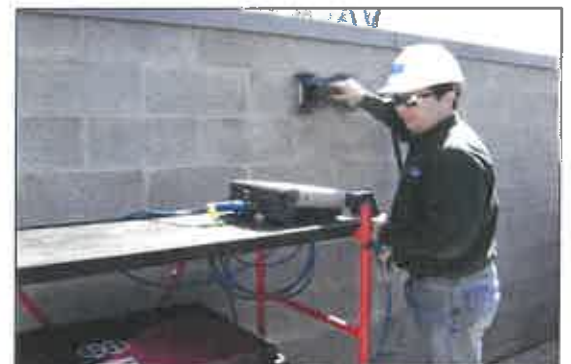
Surface Penetration Radar Scan on Concrete Masonry
